Step-fix

Repairs to steps and pallets on site

EFFICIENT REPAIRS ON SITE WITH STEP-FIX

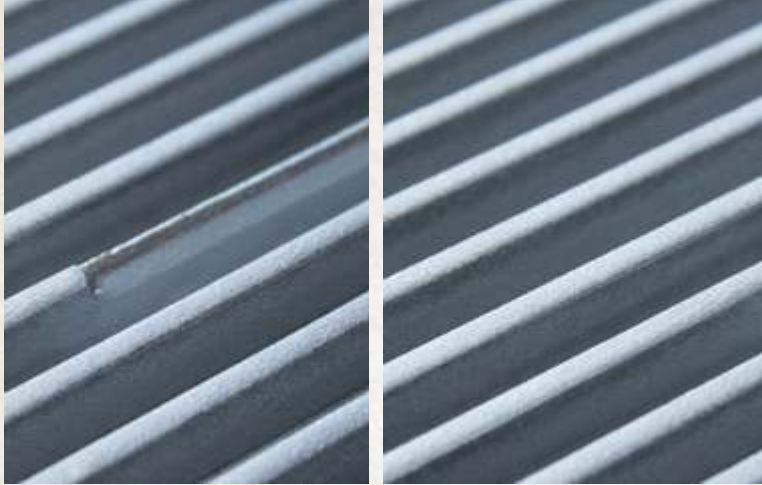
Mulder Montage has developed a method for repairing worn ribs on the standing areas of escalator steps and moving walk pallets. This patented method is based on repairing damage using a filler material, returning the worn rib to its original form. In Scandinavia the step-fix is performed by Nordic Installation that are located in Sweden.

Before

After

According to NEN-EN115 standards, the ribs on the standing areas of escalator steps and moving walk pallets must comply with requirements for minimal dimensions. This is in the interests of safety for the users. Various external factors (such as stones trapped between comb plates) can cause damage to the ribs and pallets, so that they no longer meet the dimensional requirements. Damage will be detected during periodic inspections and must be rectified before the installation can be approved under NEN-EN115 standards.
